Manhole Inspection Summary

Manhole # S33CC_015MH

Inspection ☐ Is Incomplete Rating: **3) Fair**

Location Address: **1023 N. Charles**

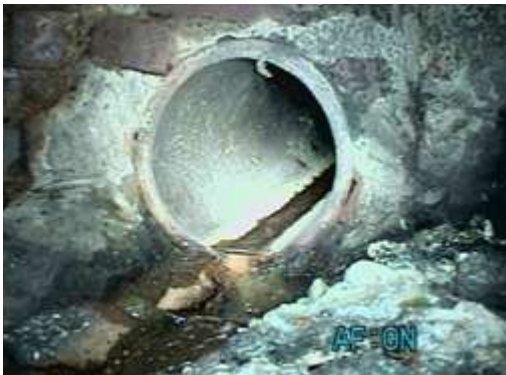
Defect 1

Condition: ☐ Sound ☐ Cracked ☐ Root Intrusion ☐ Deteriorated ☐ Leaks ☒ **Debris**

bench debris

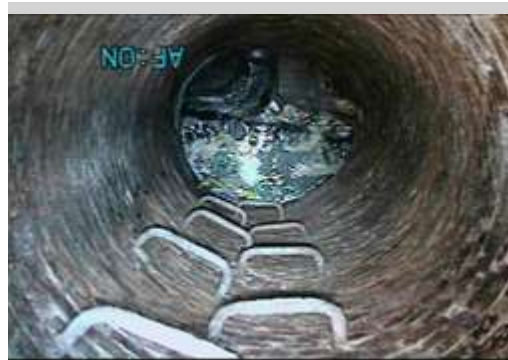
Defect 2

Count: **12** Missing: **0** ☒ **Corroded**

corroded steps

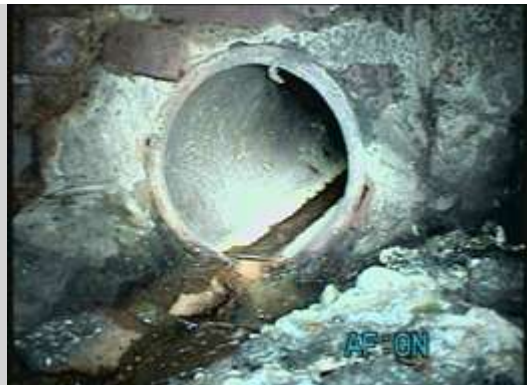
3 O'Clock Inflow

Deposits: ☐ None ☐ Mud ☐ Sludge ☒ **Debris** ☐ Grease

Silt Depth: 1 (in.) Deposits Extent: **Light**

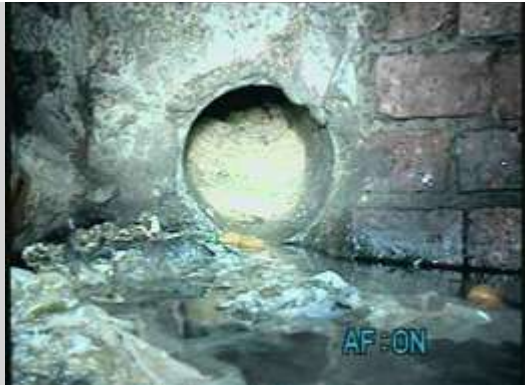
4 O'Clock Inflow

Deposits: ☐ None ☐ Mud ☐ Sludge ☒ **Debris** ☐ Grease

Silt Depth: **6** (in.) Deposits Extent: **Heavy**
